Contract #: 04-0120F4Cty: SF/ALA Rte: 80 PM: 13.2/13.9File #: 69.28**WELDING INSPECTION REPORT****Resident Engineer:**Pursell, Gary**Address:** 333 Burma Road**City:** Oakland, CA 94607**Report No:** WIR-006103**Date Inspected:** 20-Mar-2009**Project Name:** SAS Superstructure**OSM Arrival Time:** 645**Prime Contractor:** American Bridge/Fluor Enterprises, a JV**OSM Departure Time:** 1845**Contractor:** Zhenhua Port Machinery Company, Ltd (ZPMC), Changxing Island **Location:** Shanghai, China**CWI Name:** See Below**CWI Present:** Yes No**Inspected CWI report:** Yes No N/A**Rod Oven in Use:** Yes No N/A**Electrode to specification:** Yes No N/A**Weld Procedures Followed:** Yes No N/A**Qualified Welders:** Yes No N/A**Verified Joint Fit-up:** Yes No N/A**Approved Drawings:** Yes No N/A**Approved WPS:** Yes No N/A**Delayed / Cancelled:** Yes No N/A**Bridge No:** 34-0006**Component:** Tower Fabrication**Summary of Items Observed:**

Tower Bay 10

WELDING INSPECTION REPORT

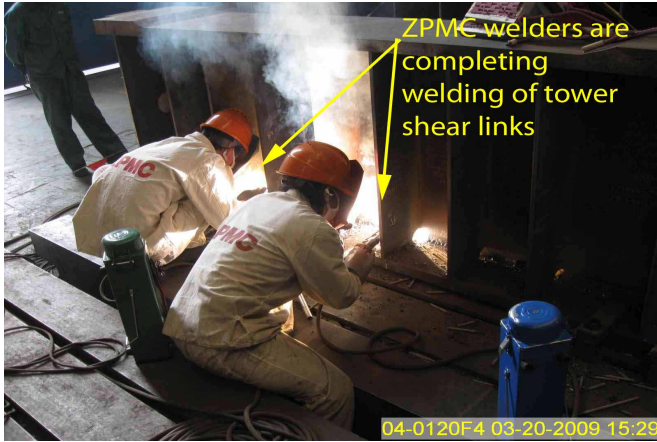
The QA Inspector observed ZPMC welder Mr. Huang Zhao, stencil 056200 is using welding procedure WPS-B-T-2212-TC-U5B to make a shielded metal arc fillet weld on shear link weld WDI-A467-18M-3-1A. The QA Inspector observed ZPMC CWI Mr. Wu Ming Kai had documented that Mr. Zhao had a welding current of 226 amps and a travel speed of 173 mm per minute. QA Inspector observed ZPMC personnel had installed electric heaters to preheat and maintain the base material temperature adjacent to where the weld was being deposited. Items observed by the QA Inspector appear to comply with project specifications. See the photograph below showing Mr. Gao Qiang and Mr. Huang Zhao welding shear link assemblies.
